CWA COMPLIANCE EVALUATION INSPECTION REPORT
U.S. ENVIRONMENTAL PROTECTION AGENCY, REGION 5

Purpose:
Compliance Evaluation Sampling Inspection

Ex. 6 (Personal Privacy) Farms

Date of Inspection:
November 6, 2013

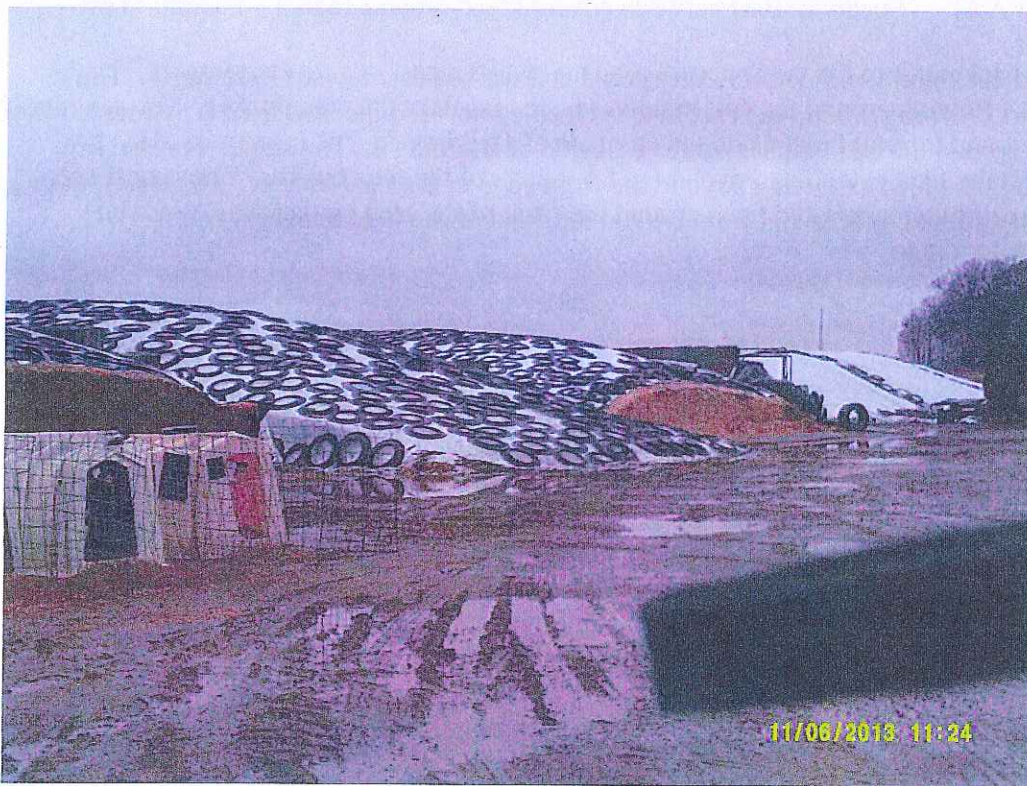
Then inspectors then walked back north to the north access road and walked east toward Building 1. The inspectors noted surface runoff flowing around the calf hutches located north of the feed bunker. Surface runoff was also seen flowing from around the calf hutches on the east side of Building 3. The inspectors also saw surface runoff flowing through the feed extending beyond the front edge of the feed bunker. The runoff seen flowing from around the two calf hutch areas and from around the front of the feed bunker was observed flowing to the north end of center ditch.

Photo DSCF0056: Calf hutches and feed bunker.
Date/Time: 11/6/2013 11:24 A.M. Location: North of center ditch. Facing: Southwest

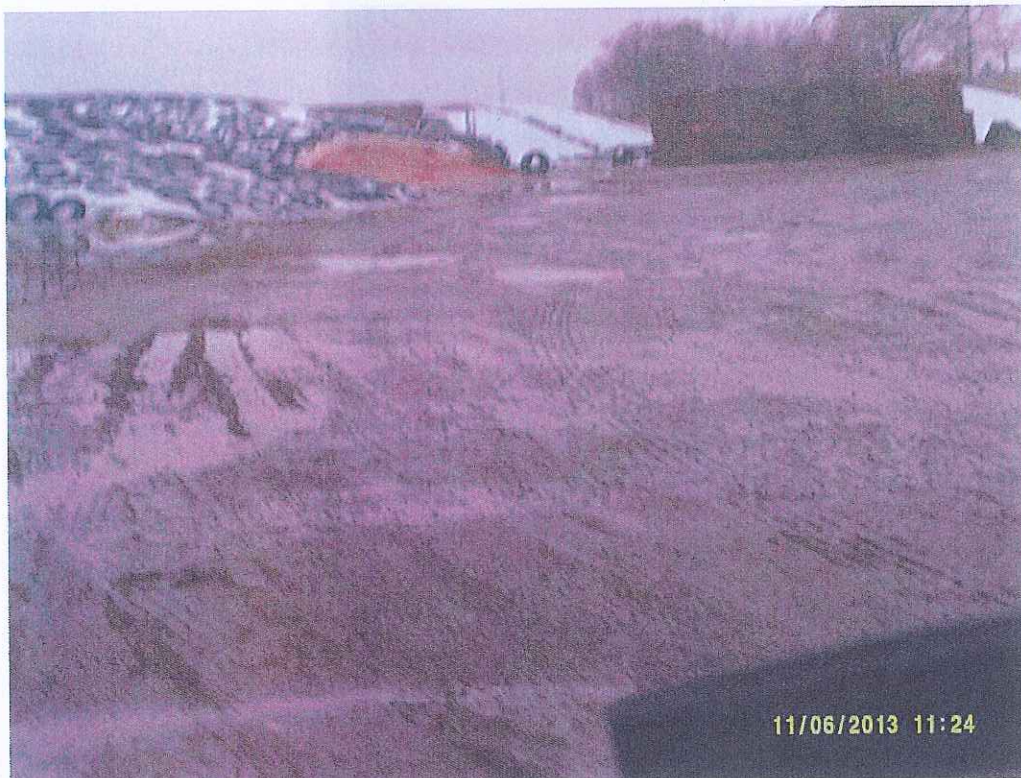
Date/Time: 11/6/2013 11:24 A.M. Location: North of center ditch. Facing: Southwest

Photo DSCF0057: Feed bunker, covered feed mounds, and compost bales.

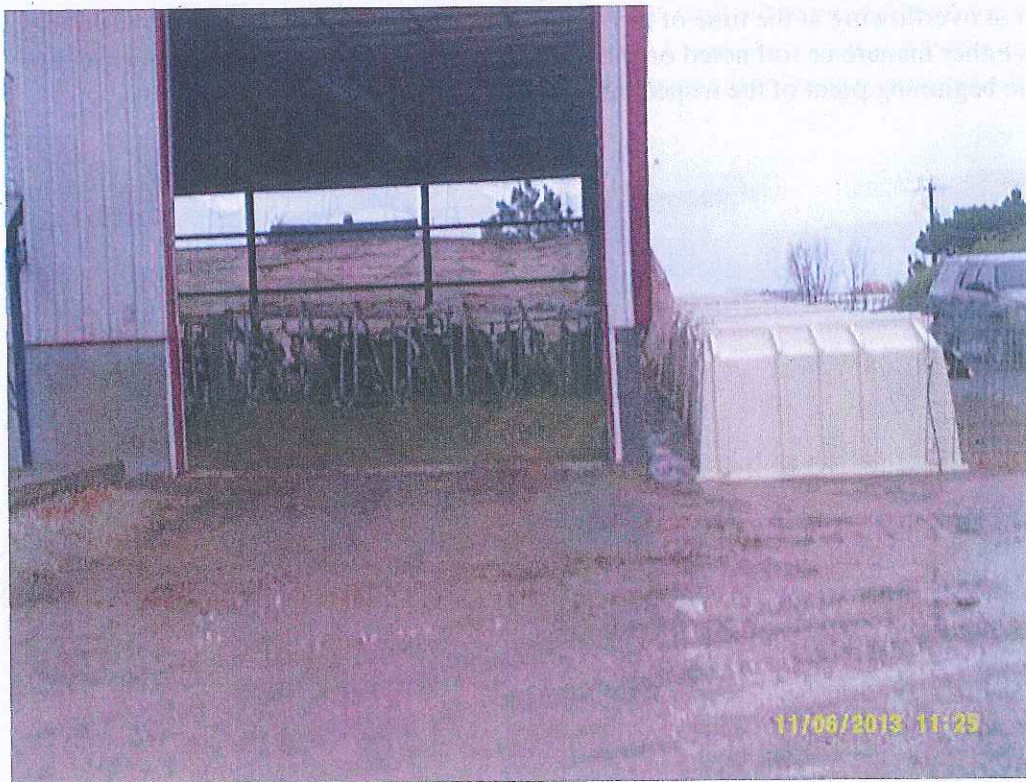
Date/Time: 11/6/2013 11:24 A.M. Location: Southeast corner of Building 3. Facing: North

Photo DSCF0058: Heifers in Building 3 and calf hutches east of Building 3.

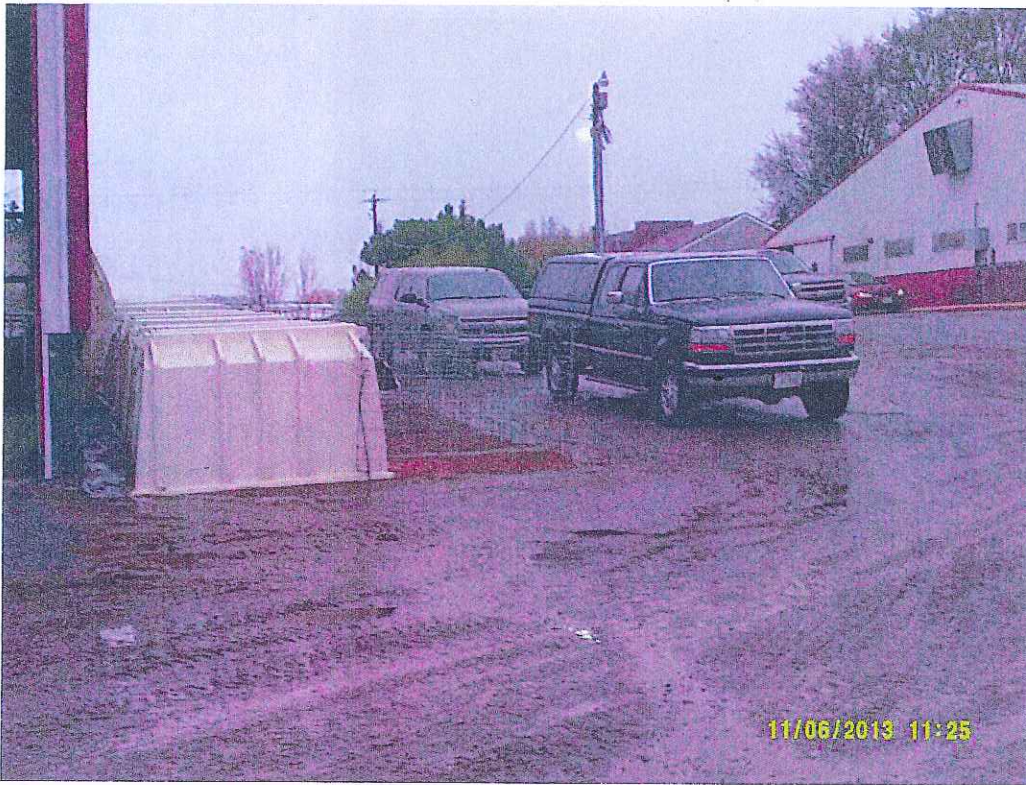
Date/Time: 11/6 /2013 11:25 A.M. Location: Southeast corner of Building 3. Facing: Northeast

Photo DSCF0059: Calf hutches east of Building 3.

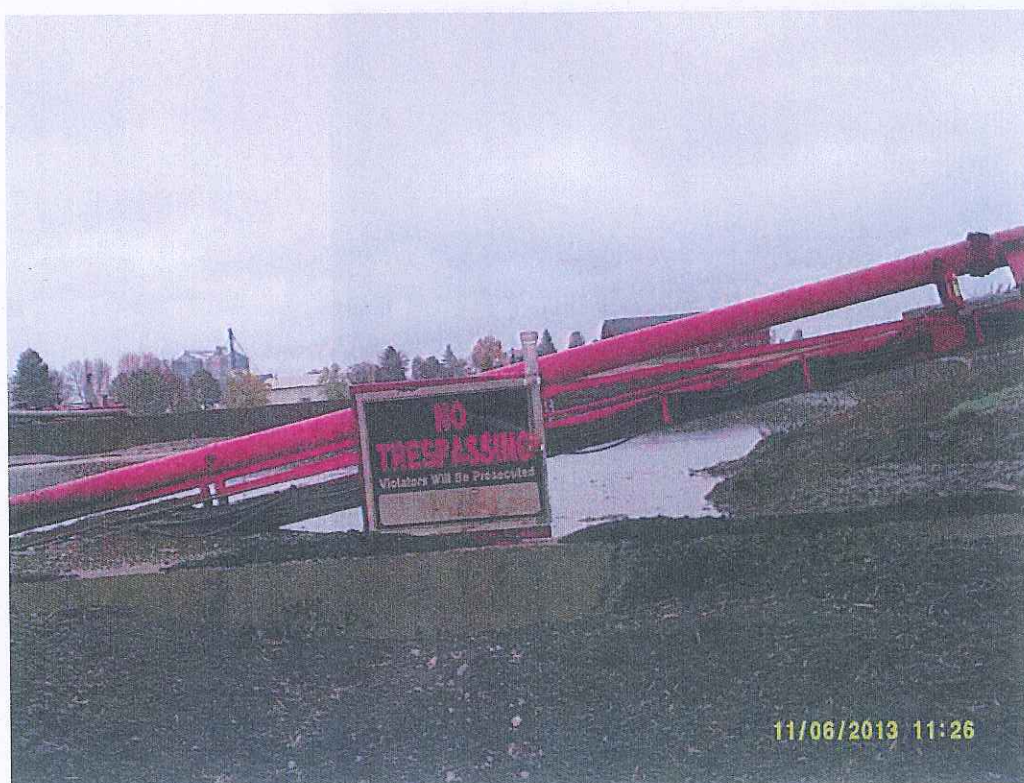
Date/Time: 11/6/2013 11:26 A.M. Location: North of the manure storage pit. Facing: South

The inspectors continued east toward Building 1. The manure storage pit had earth mounded around the concrete walls. The pit was not overflowing at the time of the inspection. There appeared to be less than one foot of freeboard. There was either manure or soil noted on the top of the manure storage structure walls. The inspectors then returned to the beginning point of the inspection.

Photo DSCF0062: Manure storage pit.

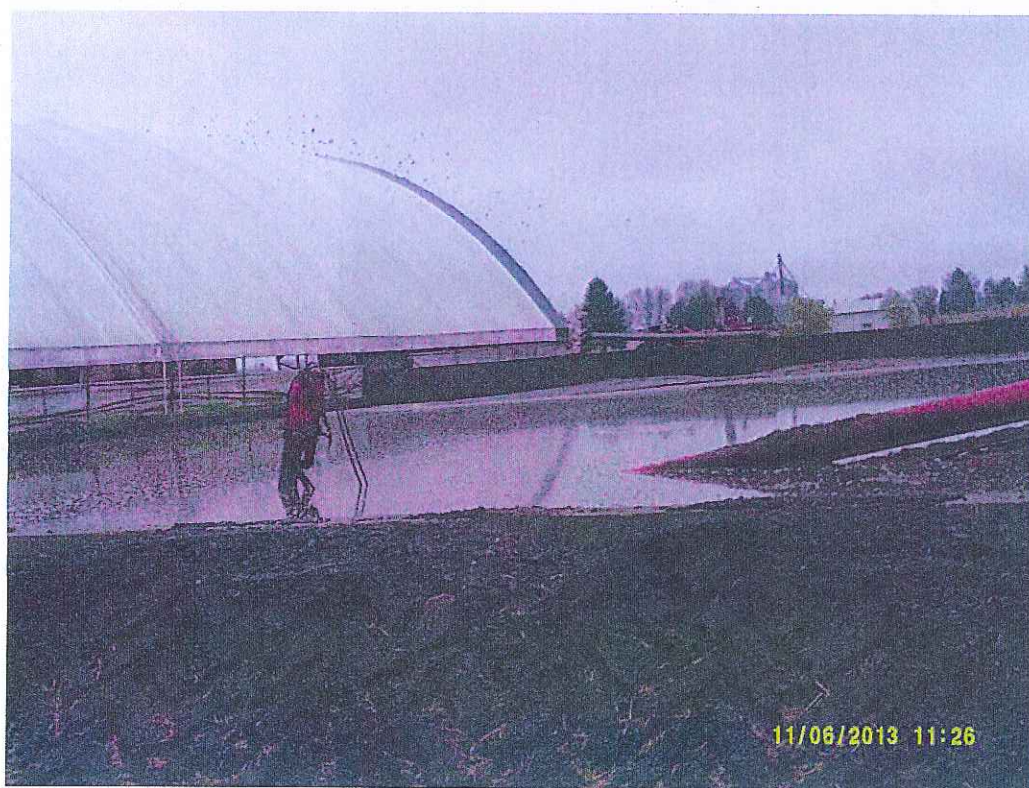
Date/Time: 11/6/2013 11:26 A.M. Location: Northwest Corner of the manure storage pit. Facing: Southeast

Photo DSCF0064: Clearer picture of the levels within the manure storage pit.

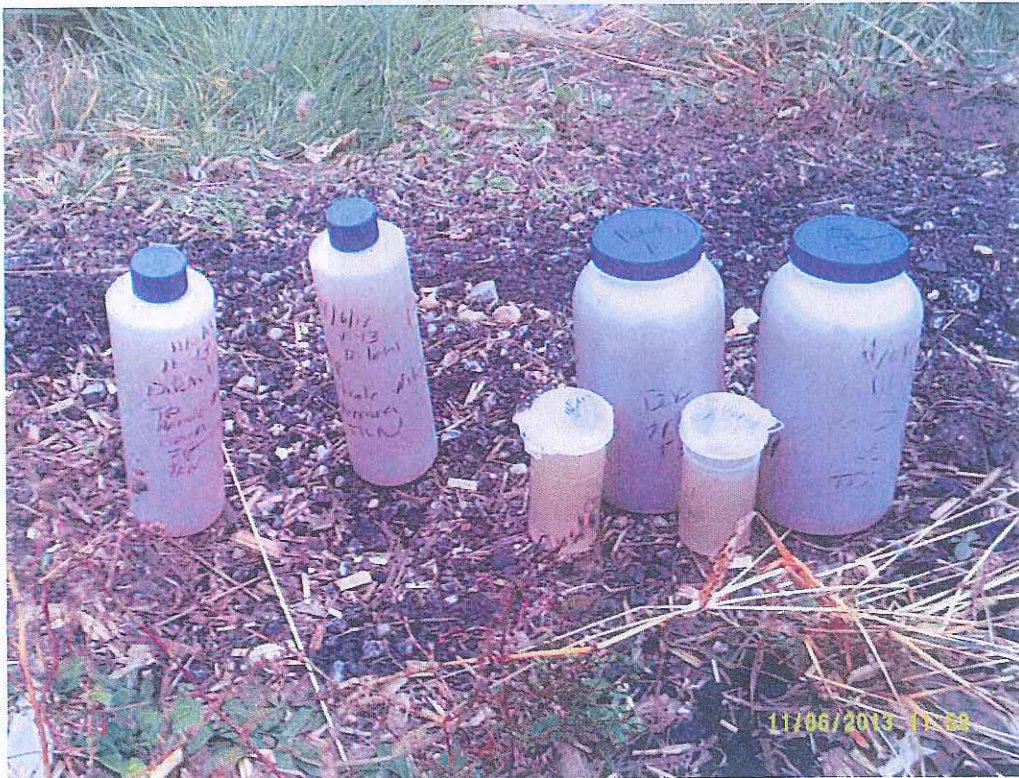
Date/Time: 11/6/2013 11:59 Location: North side of the south access road, south end of center ditch.

Photo DSCF0065: Sample S01 – "Ditch 1".

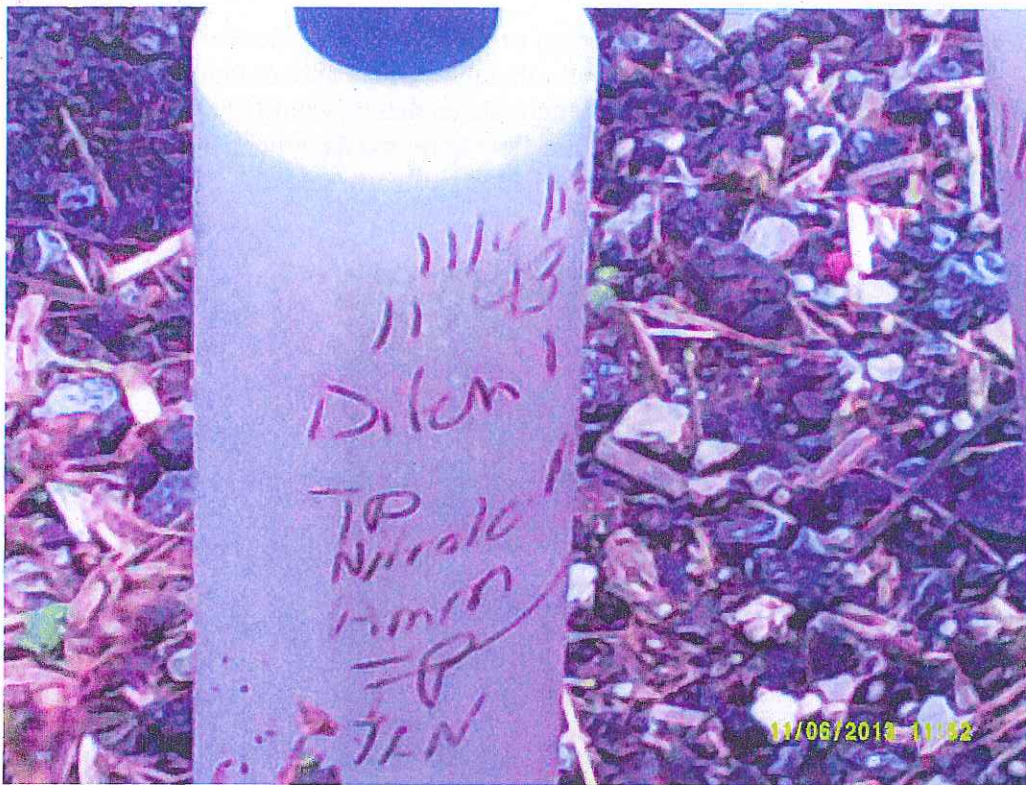
Date/Time: 11/6 /2013 11:52 A.M. Location: North side of the south access road, south end of center ditch.

Photo DSCF0066: Close-up of sample S01 – for Nutrients

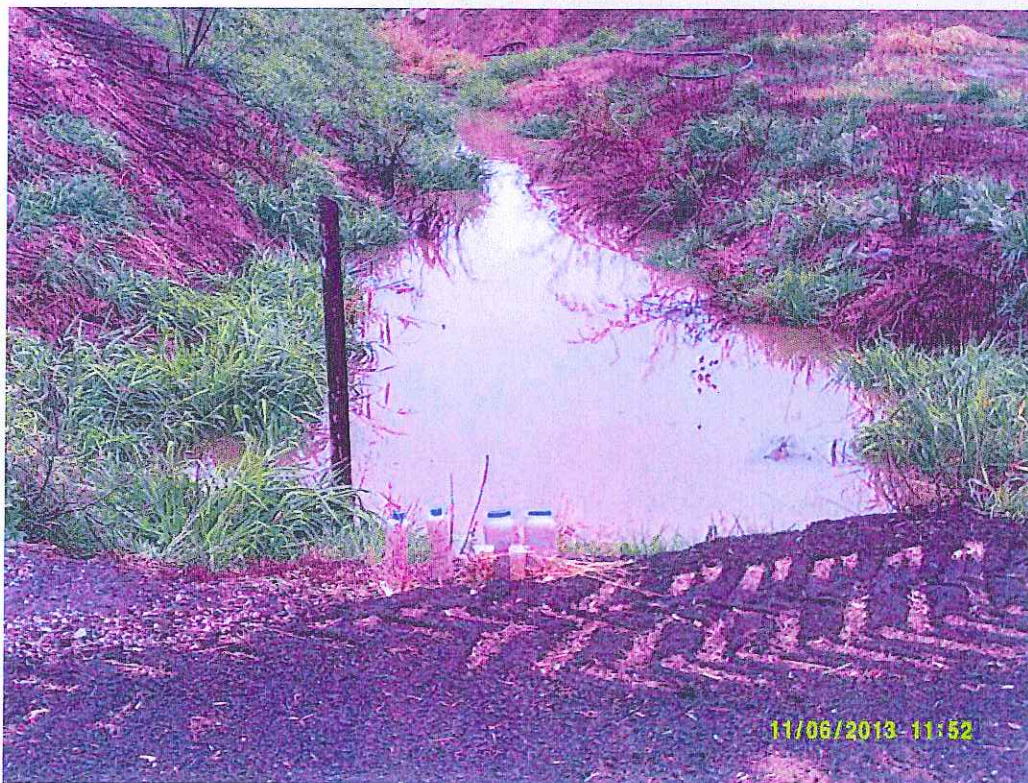
Date/Time: 11/6/2013 11:52 A.M. Location: North side of the south access road, south end of center ditch.

Photo DSCF0067: Photo of the where samples S01 were collected in Center Ditch

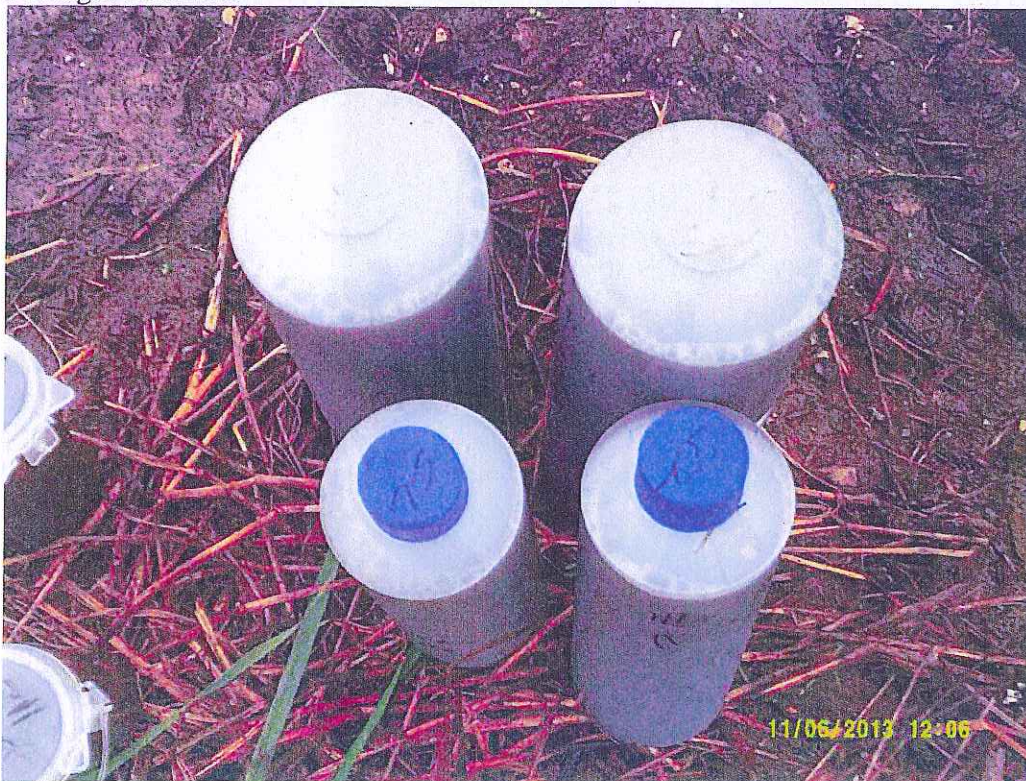
Date/Time: 11/6/2013 12:06 P.M. Location: West side of facility between covered feed mounds 1 and 2.

Photo DSCF0071: Sample S02.

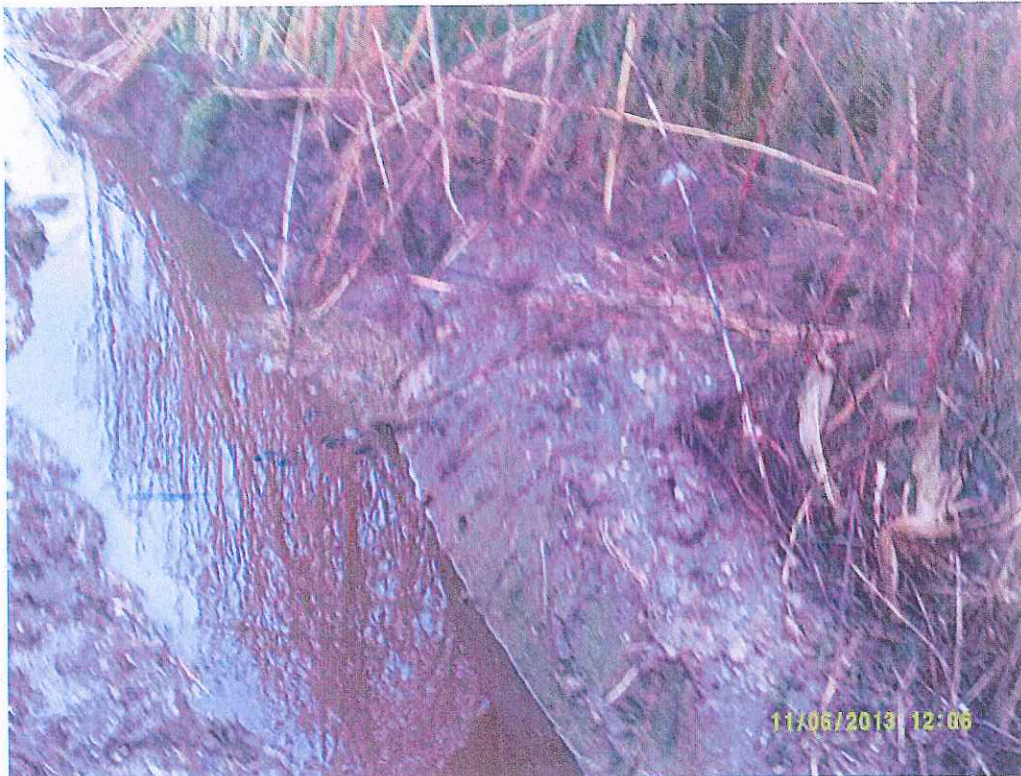
Date/Time: 11/6/2013 12:06 A.M. Location: West side of facility between covered feed mounds 1 and 2.
Facing: Northwest

Photo DSCF0072: Pathway 2 and sample S02.

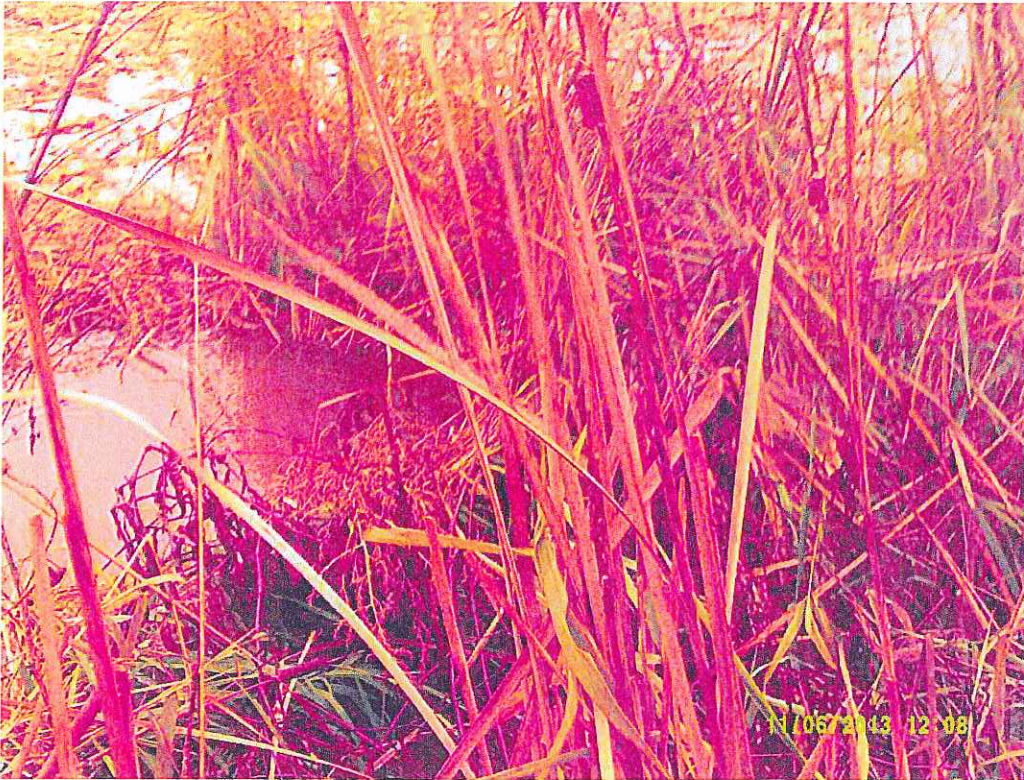
Photo DSCF0074: Water within the intermittent unnamed tributary.
Date/Time: 11/6/2013 12:08 P.M. Location: West edge of facility. Facing: West.

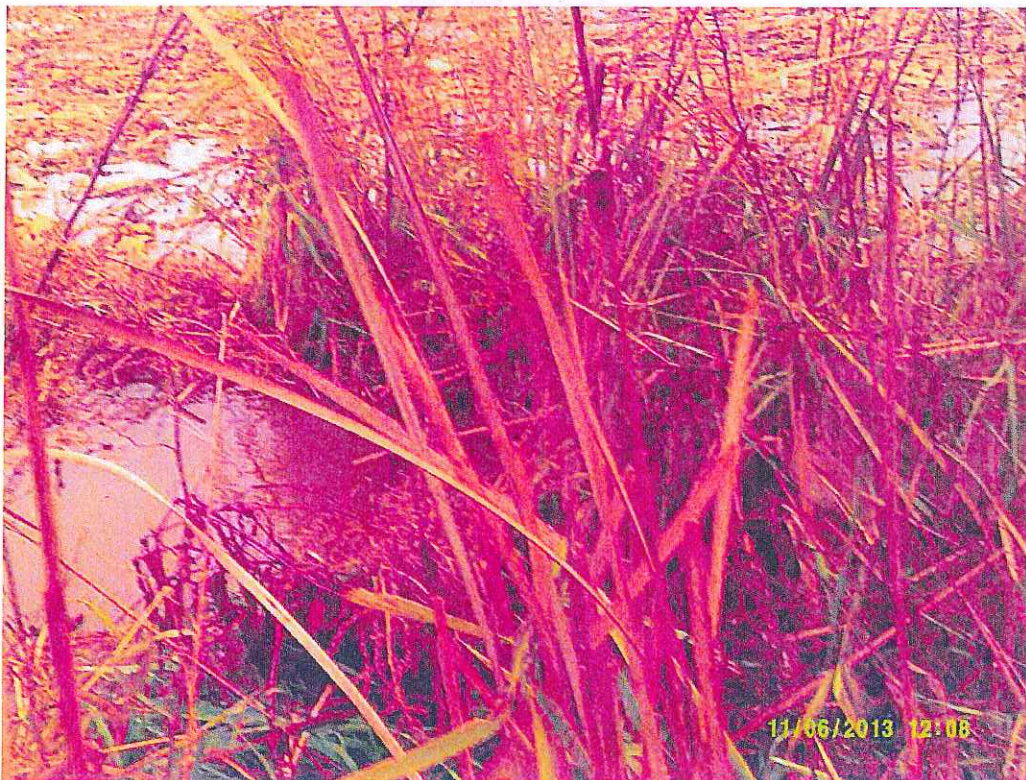
Photo DSCF0075: Water within the intermittent unnamed tributary.
Date/Time: 11/6/2013 12:08 P.M. Location: West edge of facility. Facing: West.

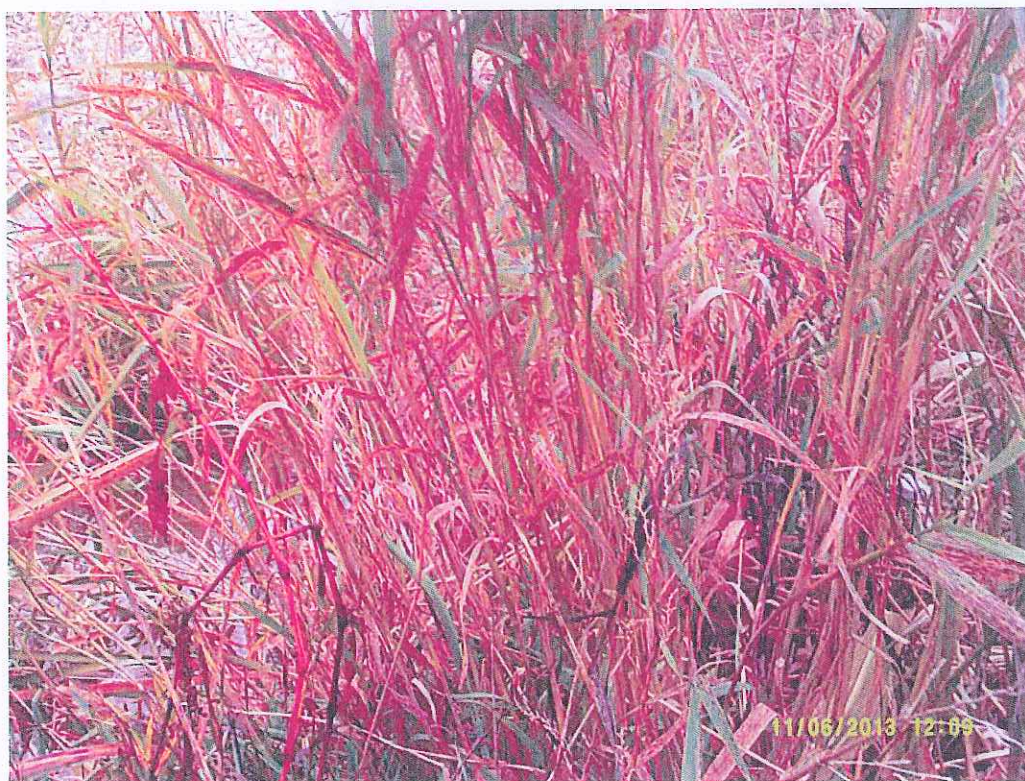
Photo DSCF0076: Water within intermittent unnamed tributary.
 Date/Time: 11/6/2013 12:09 P.M. Location: West edge of facility. Facing: West.

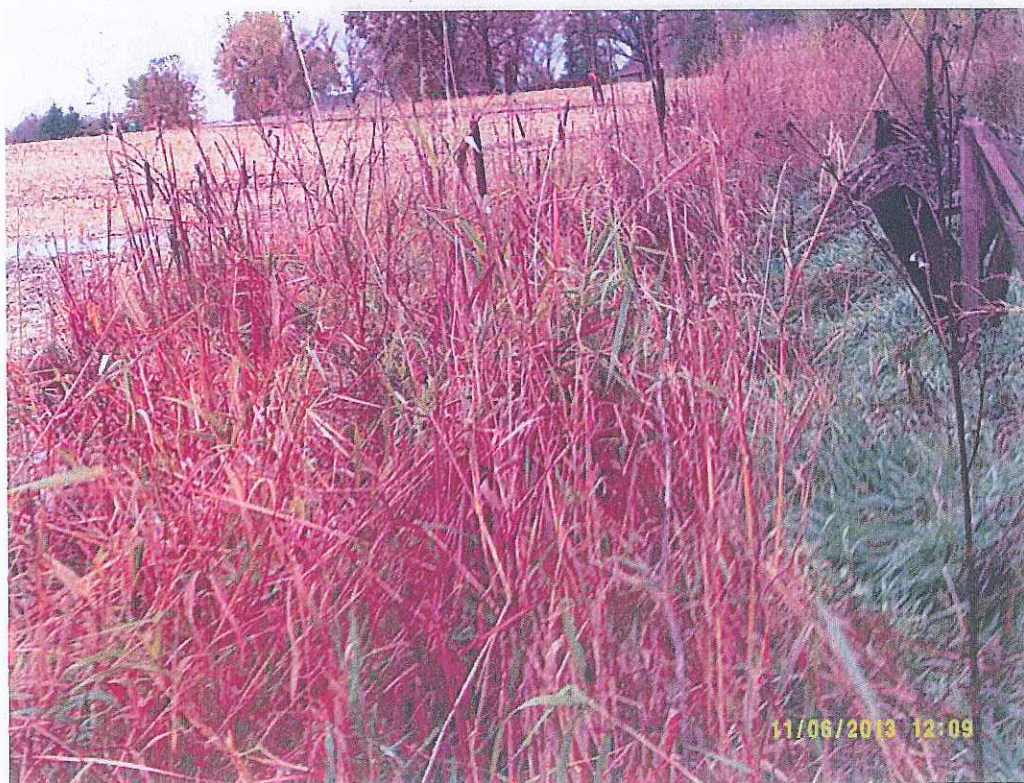
Photo DSCF0077: Intermittent unnamed tributary.
 Date/Time: 11/6/2012 12:09 P.M. Location: West side of facility Facing: Northwest

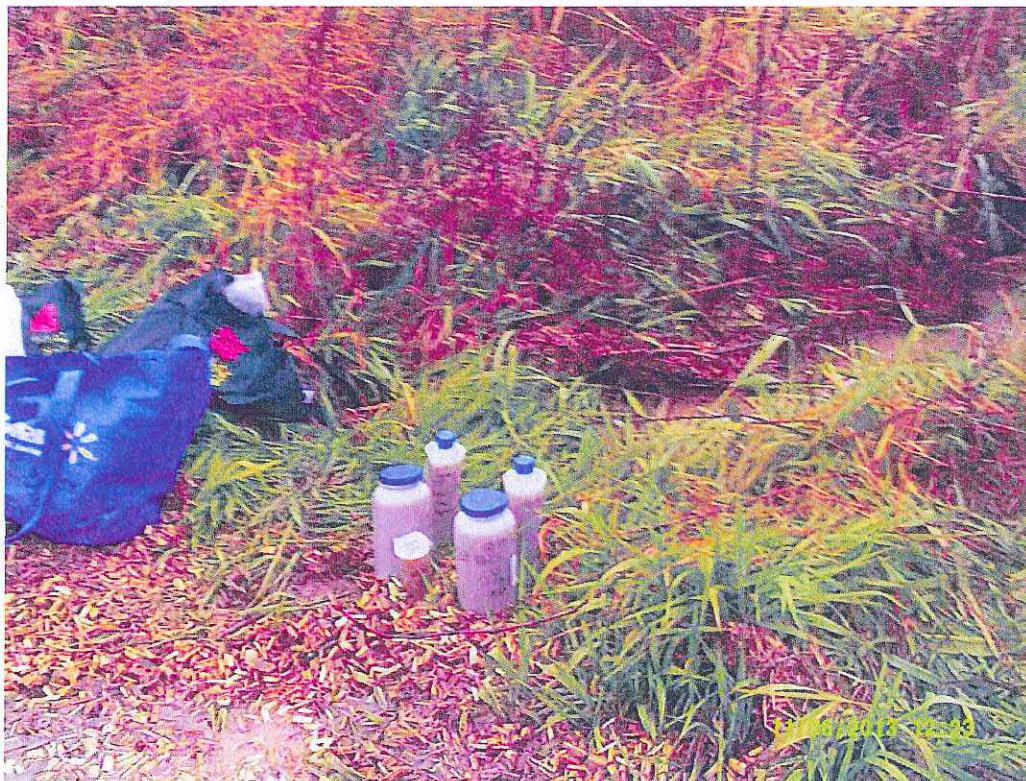
Photo DSCF0079: Sample S03 – West side of the facility.

Date/Time: 11/6/2013 12:23 P.M. Location: West between covered feed mounds 2 and 3. Facing: West

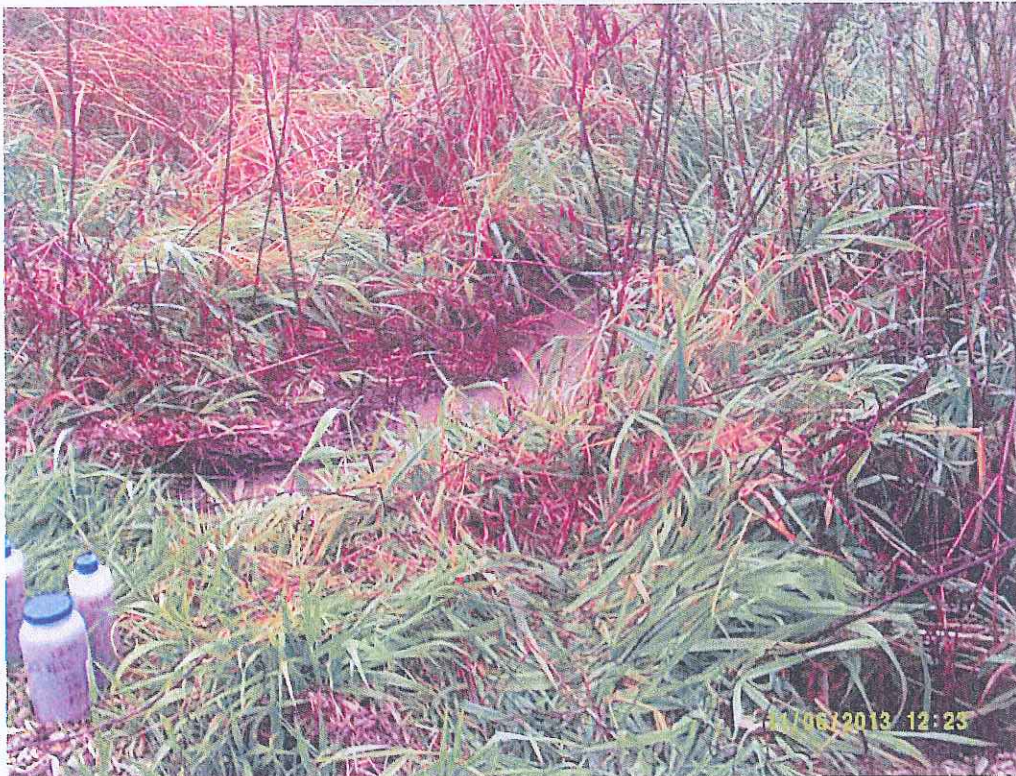
PhotoDSCF0080: Sample S03 and pathway 3.

Date/Time: 11/6/2012 12:23 P.M. Location: West between covered feed mounds 2 and 3. Facing: Southwest

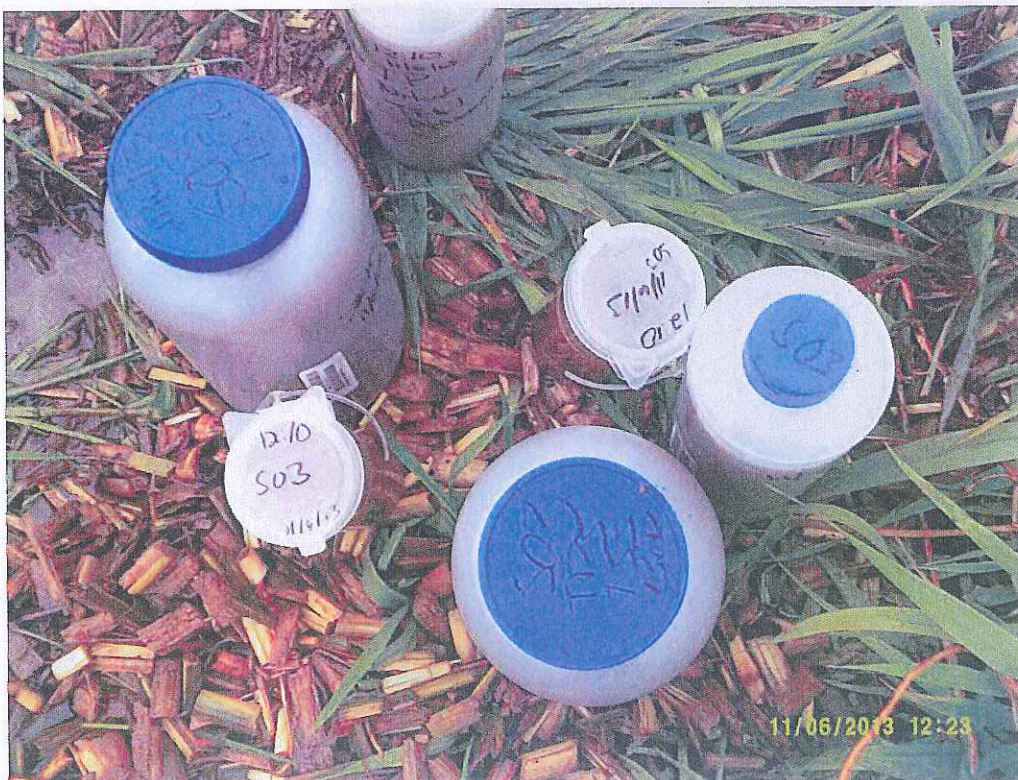
Photo DSCF0081: Photo of the tops of the Sample S03.

Date/Time: 11/6/2013 12:23 P.M. Location: West between covered feed mounds 2 and 3. Facing: Down

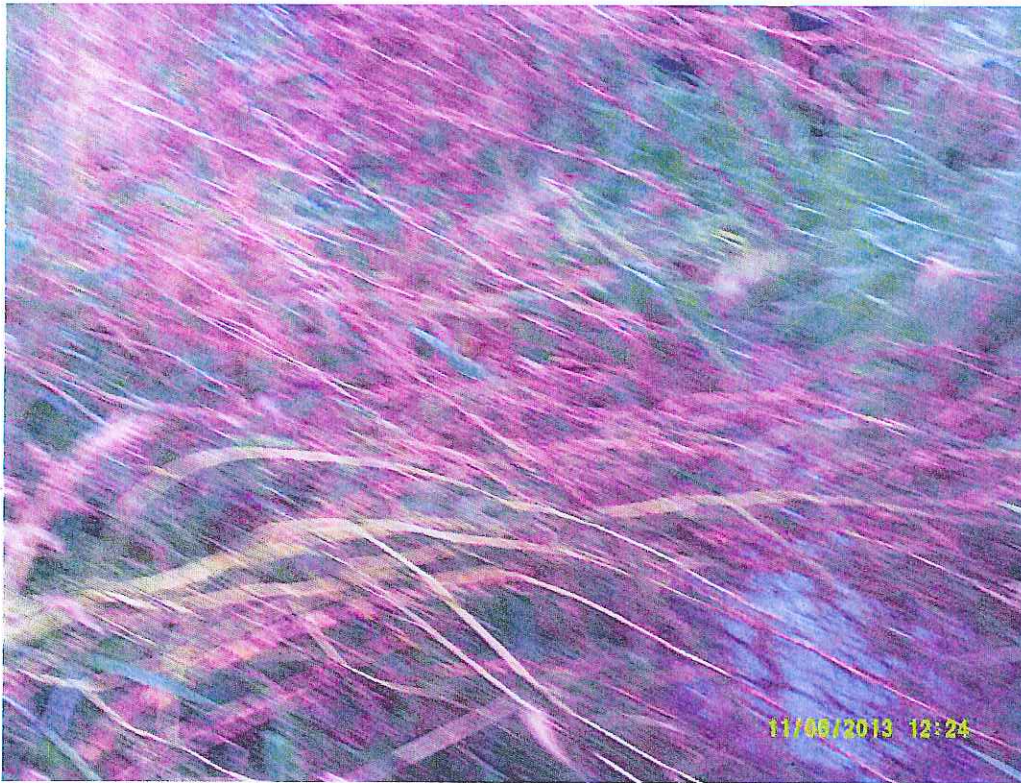
Photo DSCF0082: Blurred photo of water within the unnamed intermittent tributary.
Date/Time: 11/6/2013 12:24 P.M. Location: West side of the Production Area. Facing: Northwest.

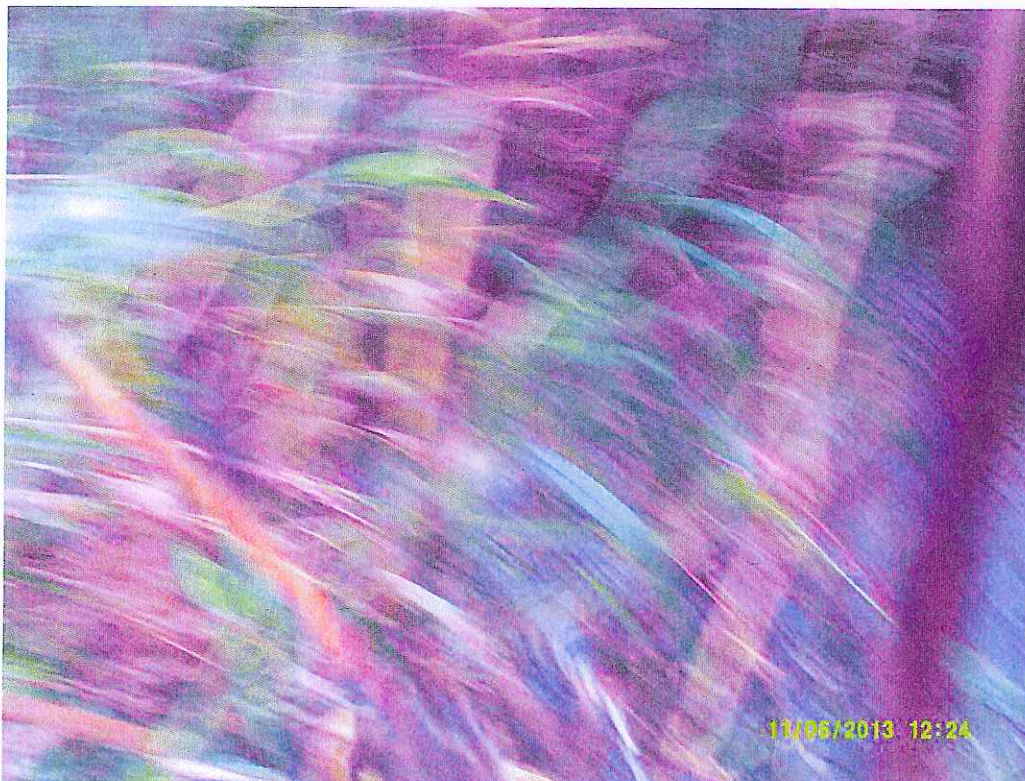
Photo DSCF0083: Blurred photo of water within the unnamed intermittent tributary.
Date/Time: 11/6/2013 12:24 P.M. Location: West side of the Production Area. Facing: Northwest.

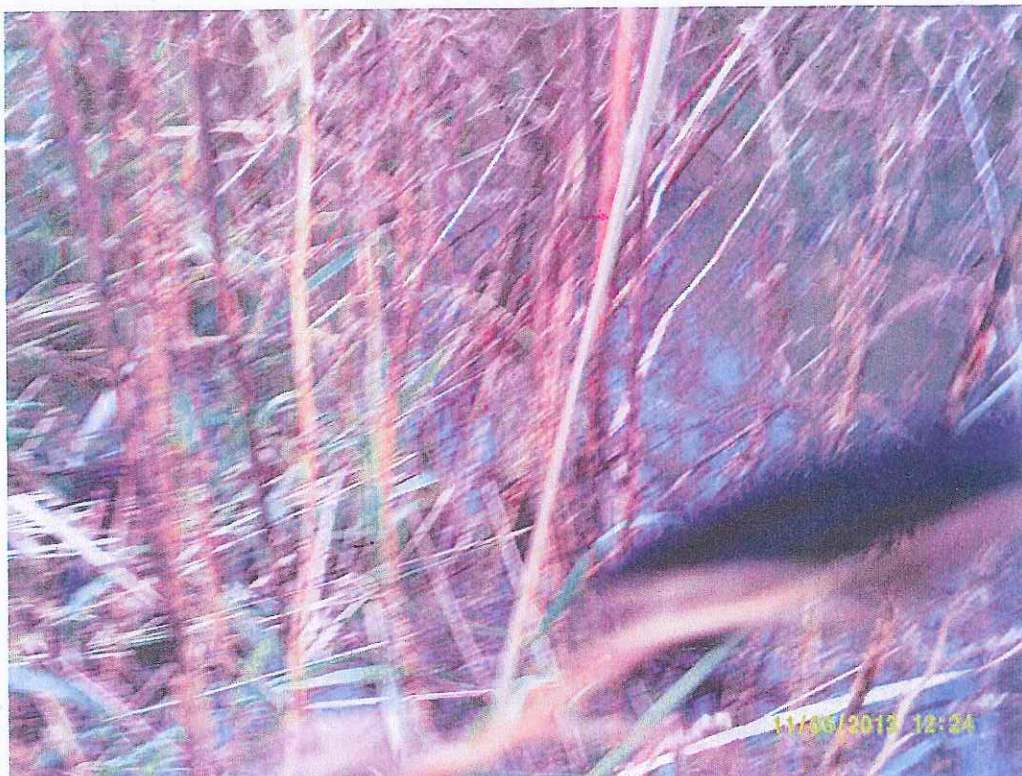
DSCF0084: Blurred photo of water within the unnamed intermittent tributary.
 Date/Time: 11/6/2013 12:24 P.M. Location: West side of the Production Area. Facing: West.

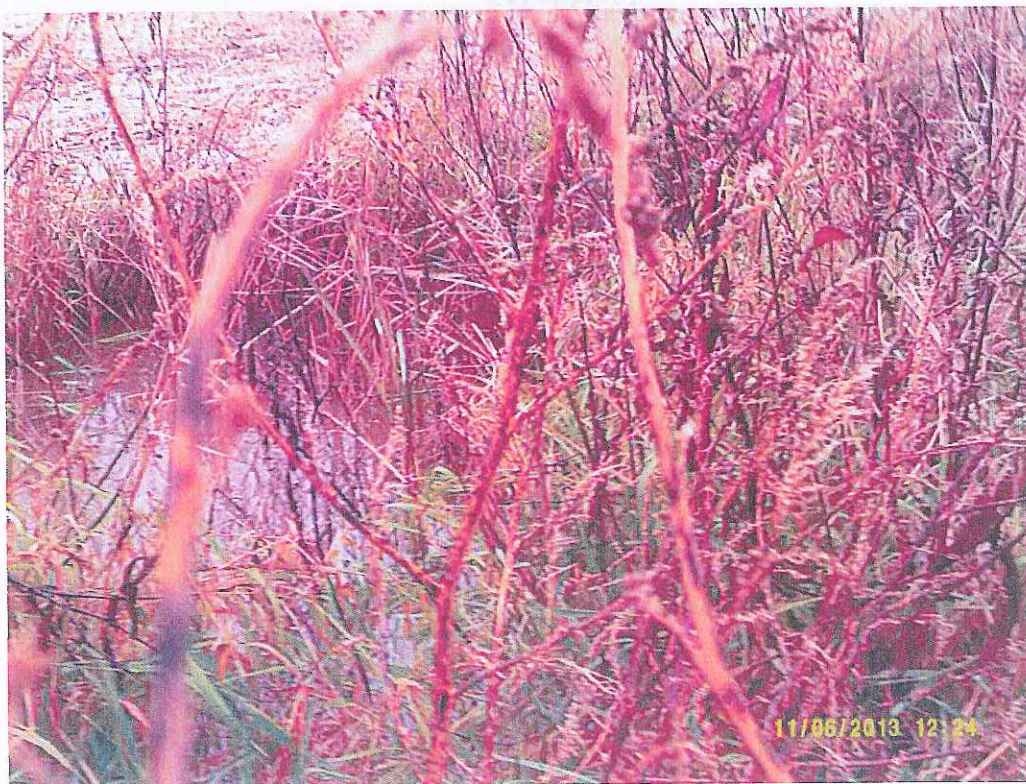
Photo DSCF0085: Water within the unnamed intermittent tributary.
 Date/Time: 11/6/2013 12:24 P.M. Location: West side of the Production Area. Facing: West.
